PIER 70 AREA
San Francisco, California

TPH SAMPLING RESULTS AND MATRICES

Date 12/16/2008 Project 4554.02 Figure 5

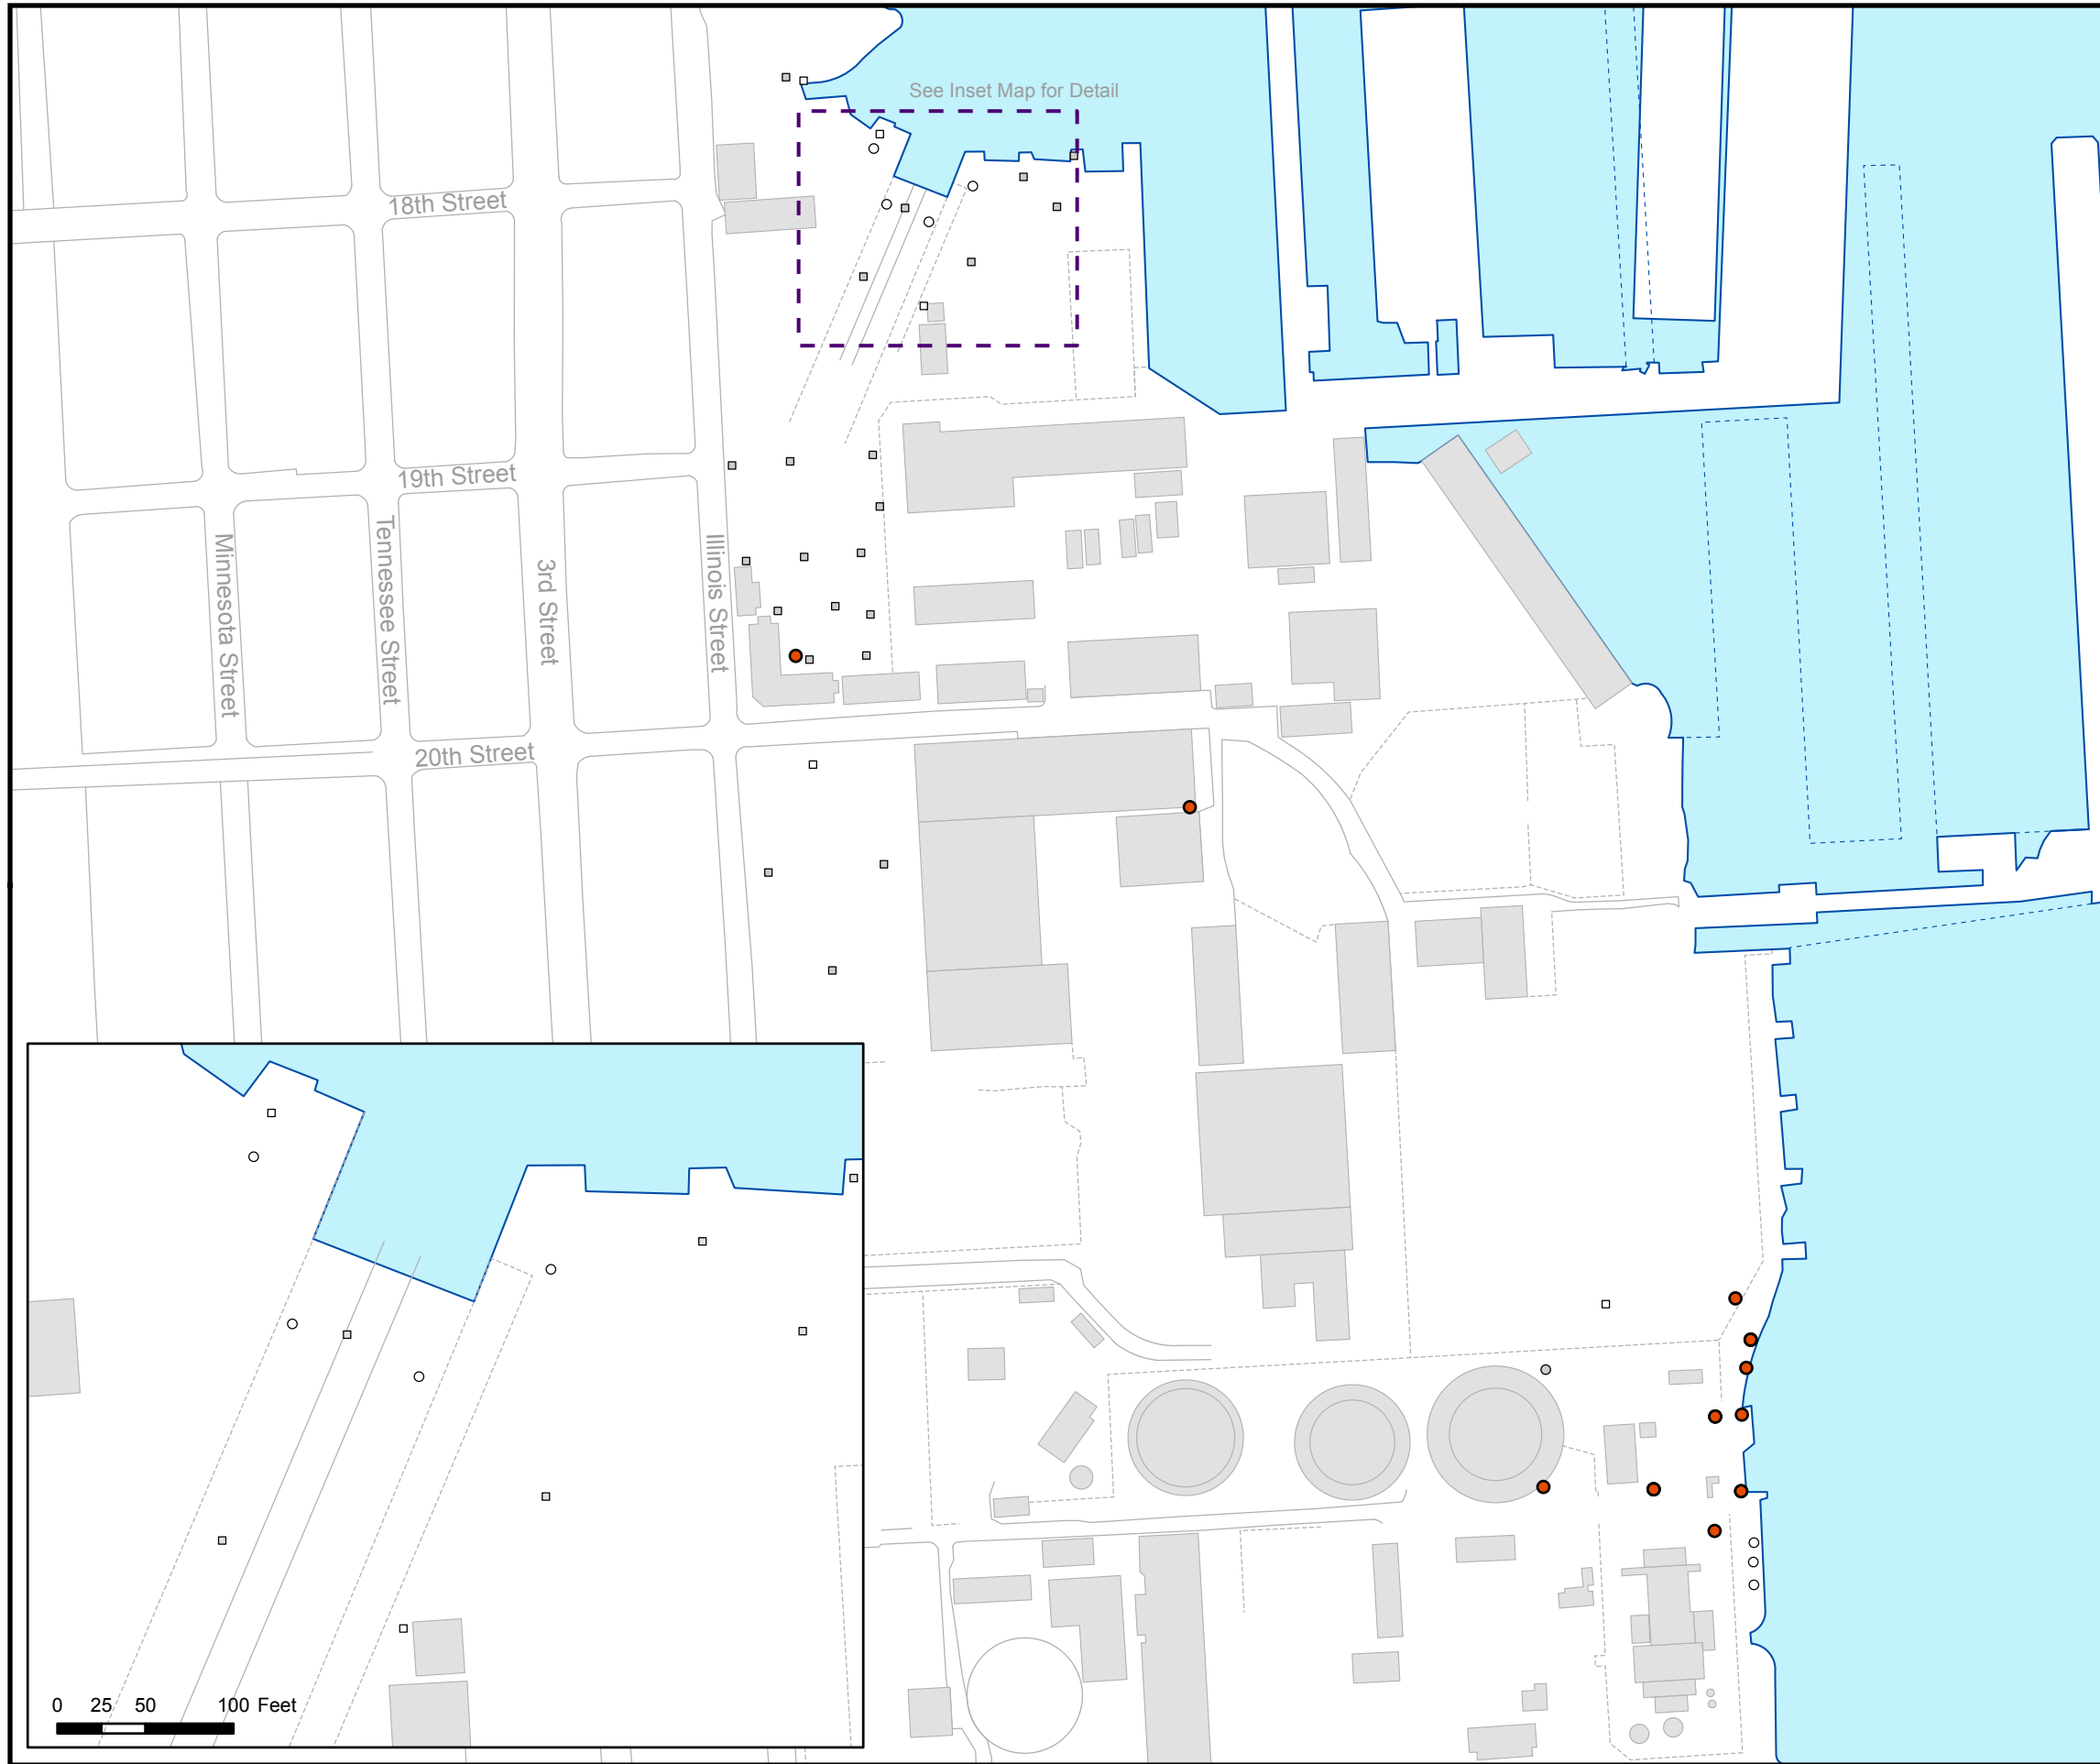
- Soil**
- Exceeds ESL
 - Detected
 - Not Detected
- Sediment**
- ◆ Exceeds ESL
 - ◇ Detected
- Groundwater**
- Exceeds ESL
 - Detected
 - Not Detected
- Surface Water**
- ⊕ Exceeds ESL
 - ⊕ Not Detected
